RESTAURO MONUMENTALE E ARCHITETTONICO
CONSOLIDAMENTO STRUTTURALE

GALVANI – CATTANEO PALACE

PORDENONE

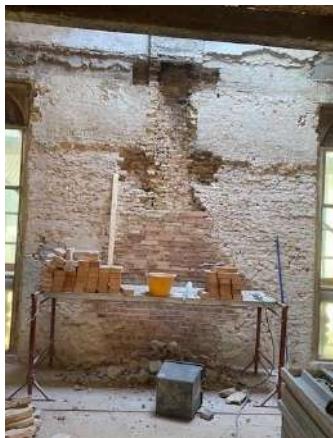
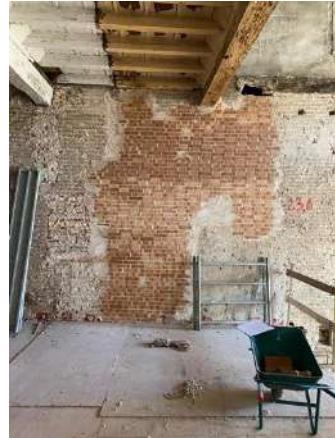
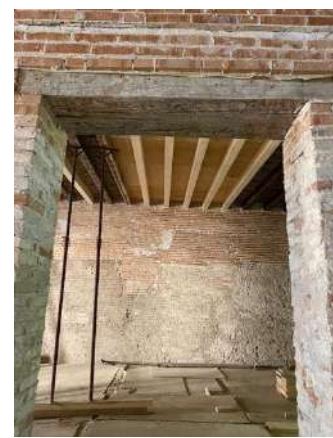
- "Scuci-cuci" technique applied to gaps created by old flues, fireplaces, drains, and utility systems to restore masonry continuity in the event of an earthquake. These elements have now been confined within cavities obtained from the redistribution of interior spaces.

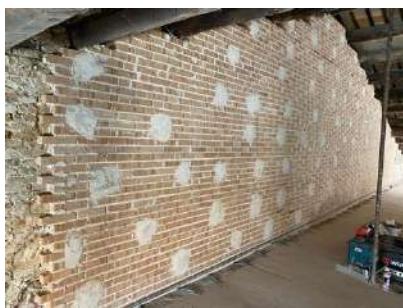
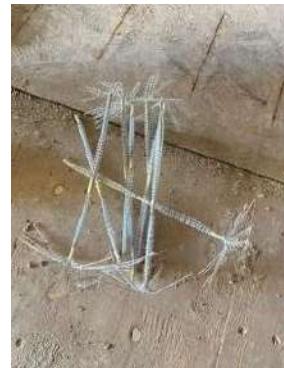
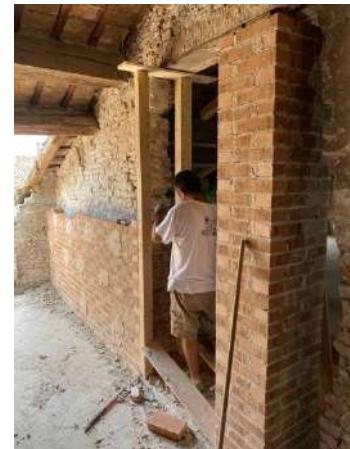
- Reconstruction of disconnected masonry sections and the creation of brick linings bonded to the existing walls, further reinforced through the insertion of galvanized steel connectors to enhance structural collaboration

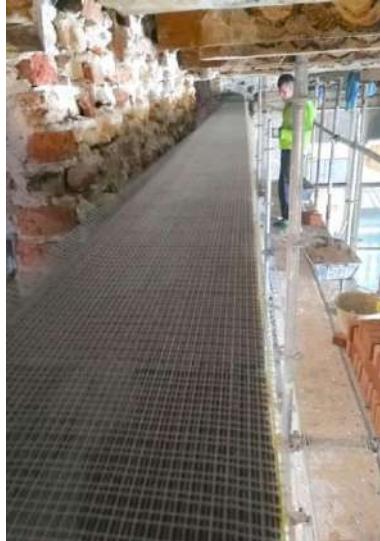
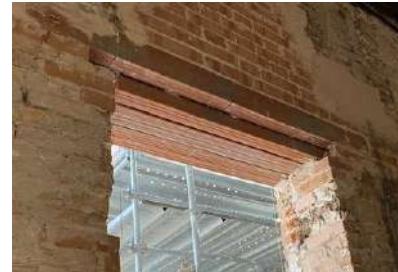
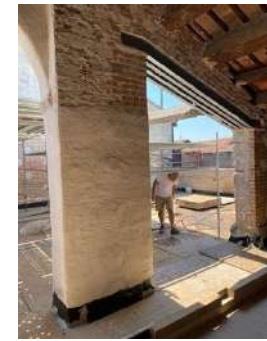
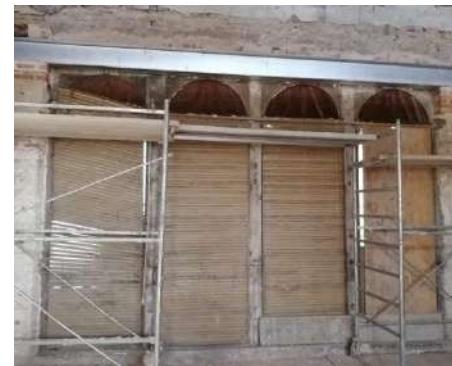
- Replacement and installation of new lintels using reinforced brick-concrete elements, steel beams, and in-situ constructions, with the insertion of galvanized steel strips within the mortar joints of the masonry.

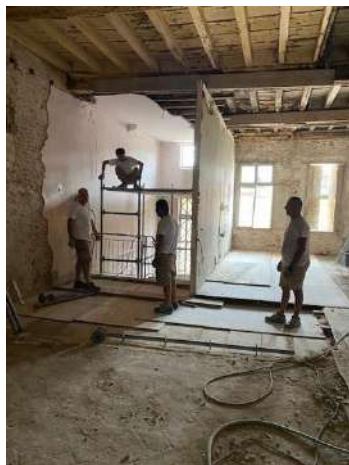
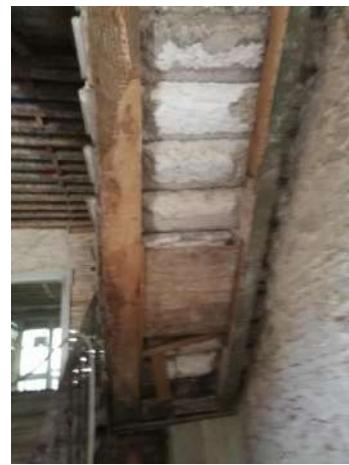
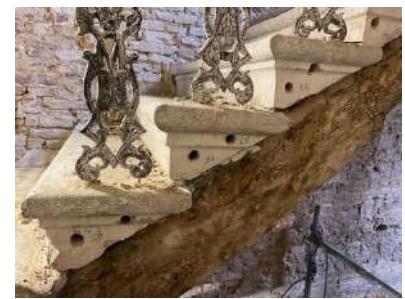
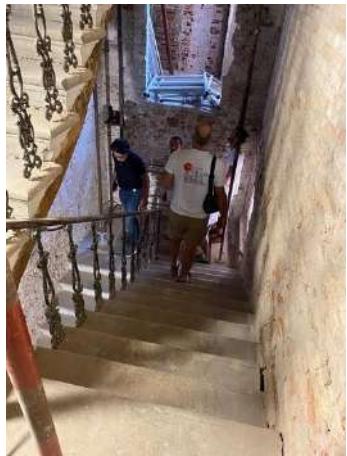
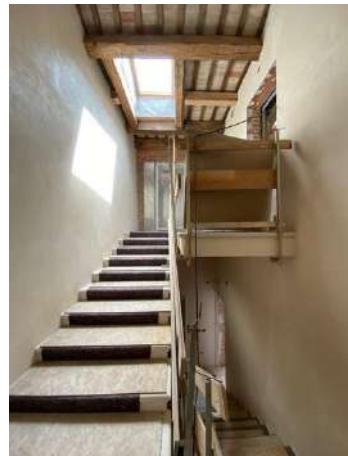
- Reconstruction of the staircase to accommodate the installation of the elevator shaft and extend the staircase to the third floor. This involved the removal of the existing staircase, followed by the flexural reinforcement of each individual step through drilling and the insertion of stainless steel bars.

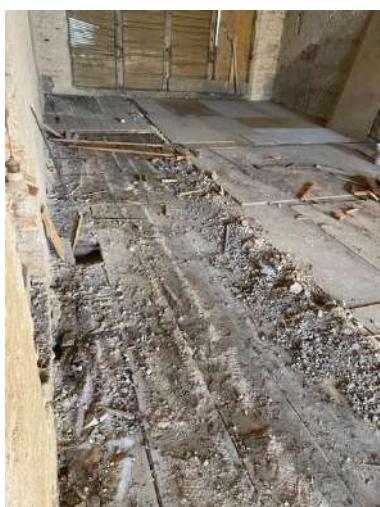
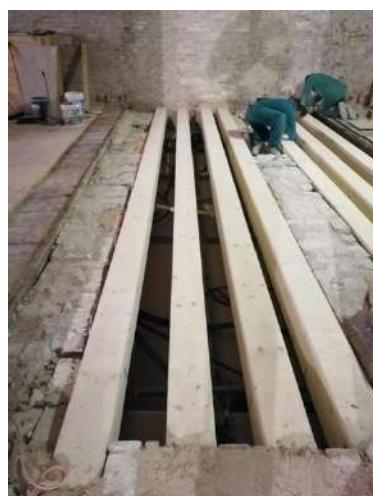
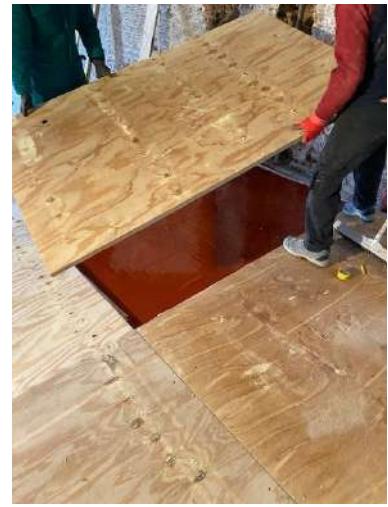
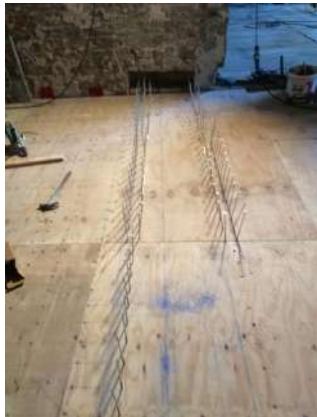
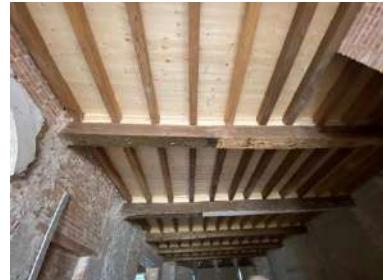
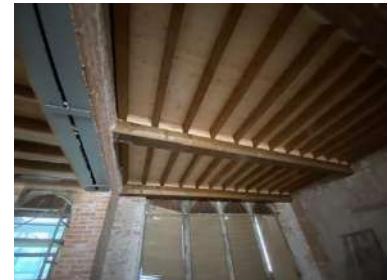
As usual in such cases, everything that could not be preserved was removed. The greatest care was given to the ceiling/floor of the noble floor, which is entirely decorated with geometric floral designs dating back to the late 1600s. The most challenging task was the preservation of the floorboards, some of which were severely damaged by woodworms. This was addressed through repeated anti-termite treatments and the application of suitable consolidants. The increased load-bearing capacity required by the floors was achieved by installing multi-layer panels, carefully glued and secured with screws to the restored and/or replaced beams.

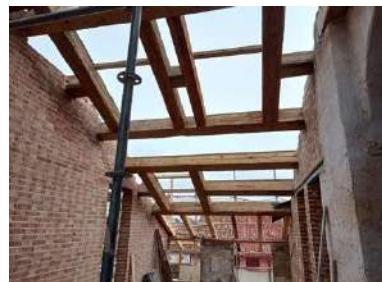
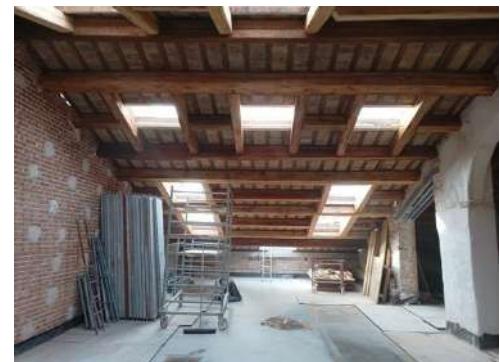
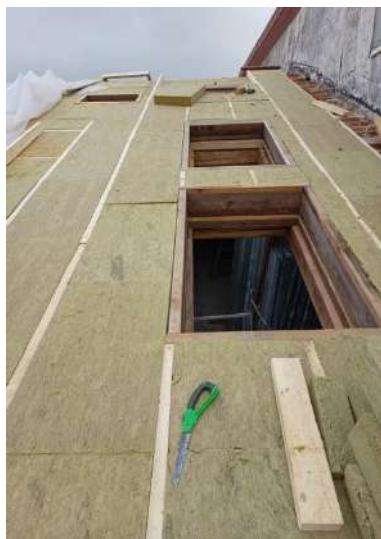
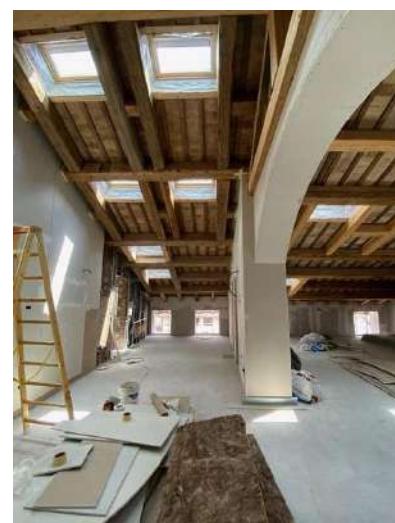
The wooden structure of the roof was completely removed and modified to make space for the various skylights required by regulations to make the attic habitable.
