RESTAURO MONUMENTALE E ARCHITETTONICO
CONSOLIDAMENTO STRUTTURALE

ASSISI UPPER BASILICA OF SAN FRANCESCO

THE CONSOLIDATION OF THE VAULT DAMAGED BY THE EARTHQUAKE

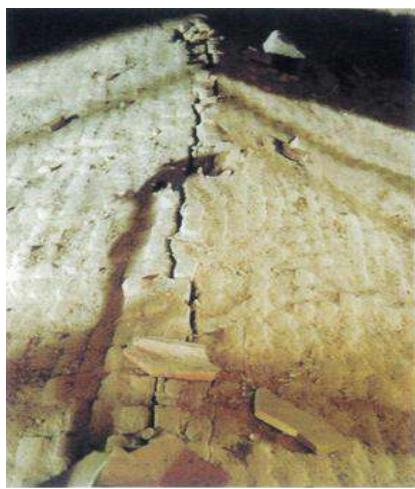
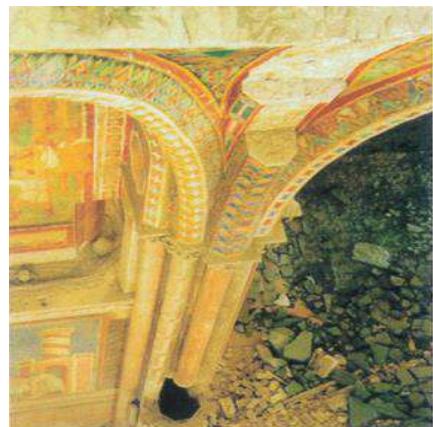
The structures affected by seismic events retain their memory, therefore being the area with high seismicity, the vaults have undergone progressive weakening and loss of shape, the latter very dangerous on structures that owe their bearing capacity precisely to the conservation of their design geometry.

At the beginning of the works many signs of previous structural discomfort were noted, with clumsy attempts to restore: this is the first serious reason to explain the collapse. Over the centuries, the waste material from roof renovations has been accumulated on the side walls, inconsistent material weighting 1,200 tons; as a result of the acceleration (about 0.2 g) caused by the earthquake, a horizontal thrust was generated on this loose material, not bound by the mortar, which caused the loss of the vaults ribs curvature forming a hinge towards the centre line and collapsed dragging the sails with them. The location of the collapses near the facade and the transept is probably due to the higher rigidity of these structural elements compared to that of the nave itself, firmly joined to them.

(Photographs illustrate the state of the vaults after the earthquake)

The surviving vaults were in a very precarious situation: there were large cracks distributed both on the extrados and on the interior; the original curvature was also lost in several areas. Since there was no possibility to intervene quickly from inside the nave due to the risk of collapse, it was decided to build a walkway suspended from the roof, in the space between it and the vaults with the dual function of allowing inspection and creating a base of work for the consolidation of the vaults to the extrados.

The design philosophy that inspired the intervention of urgency to make the vaults safe was to tie the structure in all its parts, restoring its continuity compromised by the cracking conditions state through the creation on the extrados of an exoskeleton able to absorb new and dangerous solicitations (also because seismic shocks continued to occur).

This exoskeleton had to be light in order not to add weight to the structure, elastic, to allow further small adaptations of the vaults, obtained with the use of a "drapable" material, able to adapt itself to the irregular shape of the extra dossal surface.

For all these reasons, **Carboniar®** system (Carbon Fiber Sheet Tapes and epoxy resin) has been utilized. Carbon fiber sheet enjoy an exceptional 4,900 MPa tensile strength and very low weight (1,8 kg / dm³).

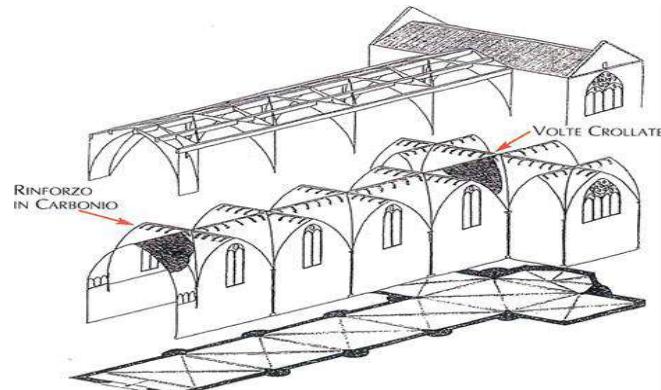
(Scheme of Carbon ribbons positioning on the vaults)

Among the various design inputs there was also that of the breathability of the frescoed surfaces: for this reason, the carbon fiber sheet tapes have been placed applied at 30-40 cm from each other, thus avoiding total coverage. About 800 linear meters of carbon sheet tapes have been applied, with a weight equal to just over 1% of the weight of the vaults.

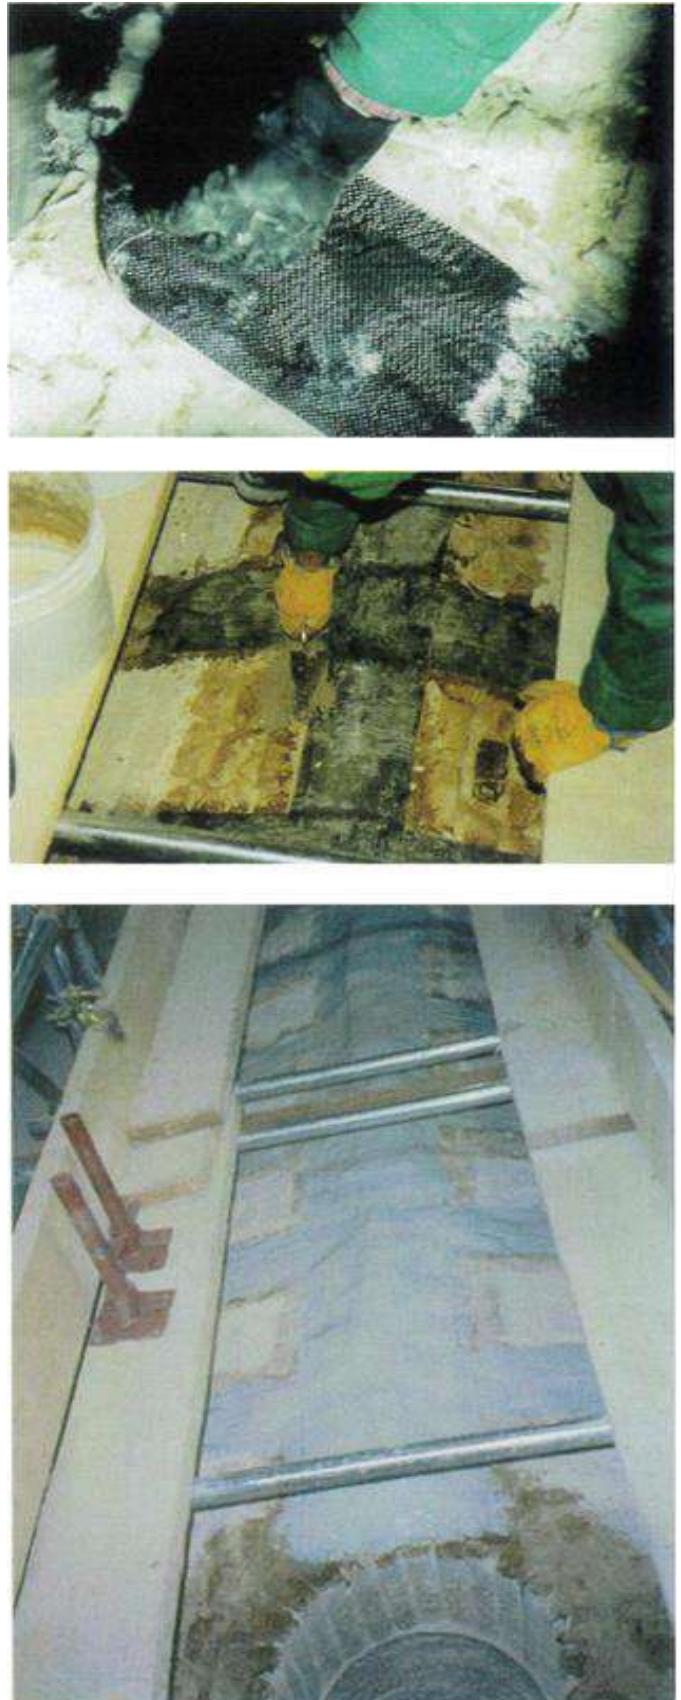
(Some application phases of the carbon fabric used to sew up the cracks)

- removal of the large amount of filling material in the kidney area of the vaults;
- sealing of cracks with a special salts free mortar to limit as much as possible the damage to the frescoes; however, every precaution had been previously taken, under the guidance of the I.C.R. (Central Institute for Restoration), by inserting as much as possible, in the lower part of the cracks, a strip of polyurethane, with the sealing function;

- thorough cleaning of the substrate, by suction of dust and surface debris;
- impregnation of bricks with diluted epoxy resins, to facilitate their penetration and to achieve a more homogeneous and deep anchoring through the creation of the so-called "epoxy needles";

- regularization of surface unevenness by the utilisation of epoxy mortar, to fill the cavities of the brick courses.
- laying of carbon fiber on previously prepared areas;

- grouting of the edges with elastic epoxy paste to improve the adhesion of the carbon in the perimeter area;
- final saturation with solvent-free epoxy-polyurethane resin to complete the reinforcement system.

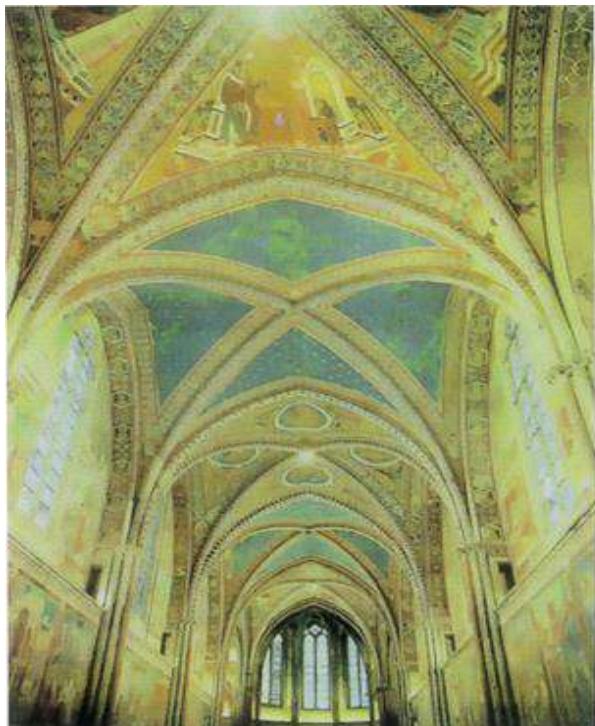
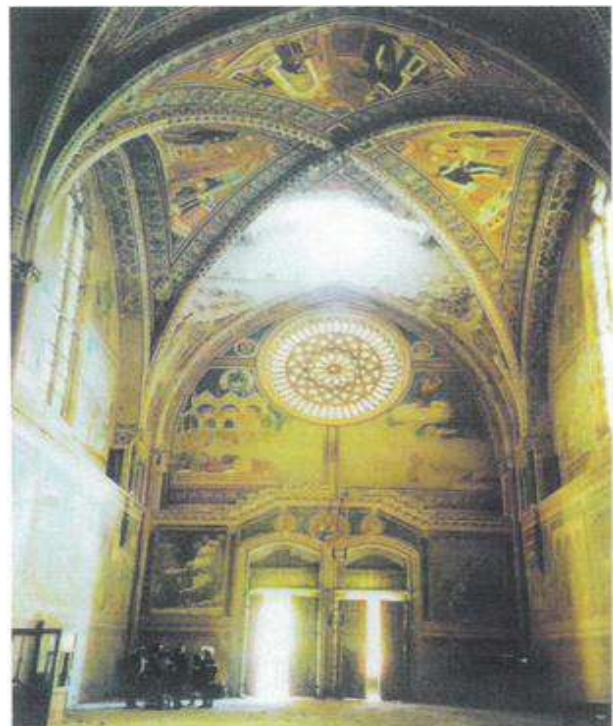
(The main nave before and after the earthquake)
