RESTAURO MONUMENTALE E ARCHITETTONICO  
CONSOLIDAMENTO STRUTTURALE

# VILLA GIOVANELLI

Noventa Padovana (PD)

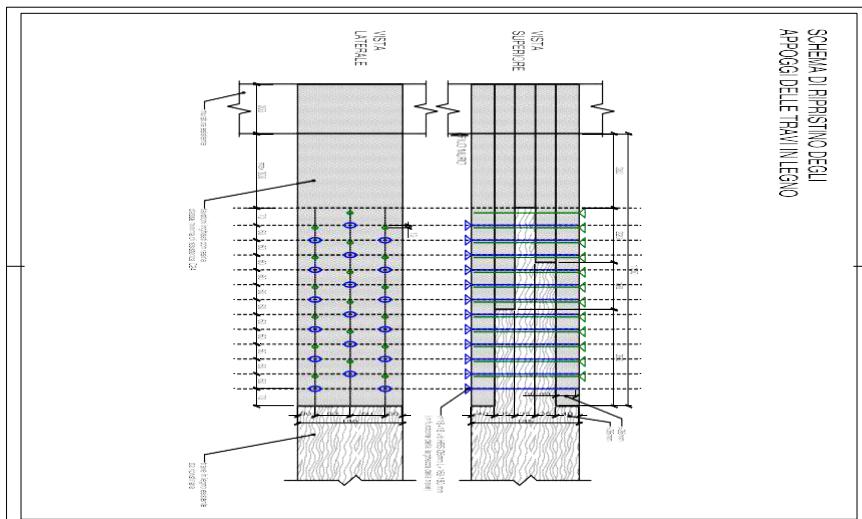
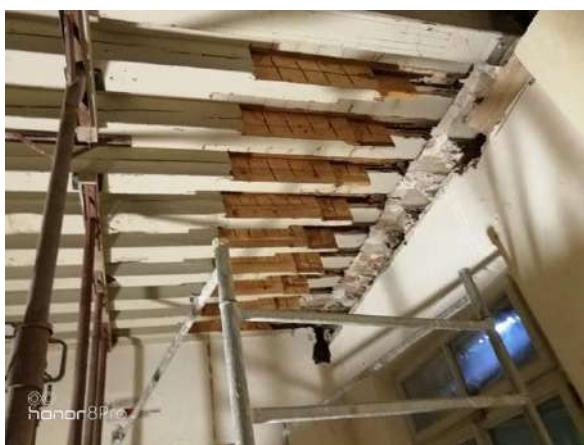
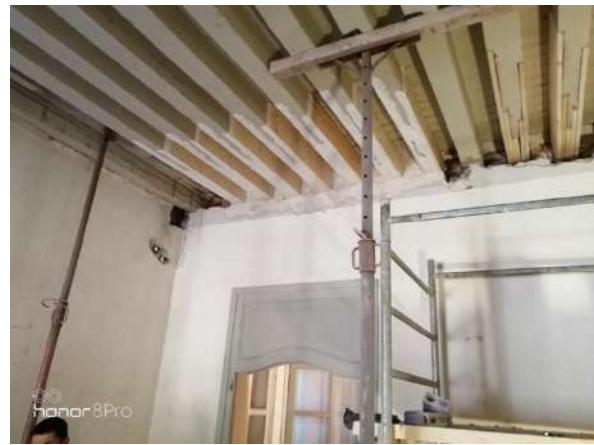
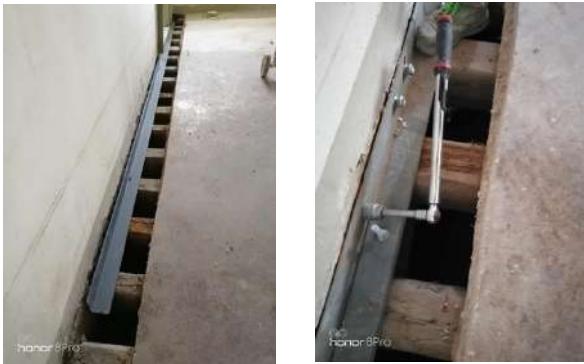
The critical issue with the floors was a widespread woodworm infestation affecting the ends of the beams, both on those supported by the perimeter masonry (more common) and on the internal beams, which were damaged due to the various uses of the rooms over time: kitchens, bedrooms, and dining halls.

The main intervention involved the lamellar reconstruction of the beam sections at the support points, carried out from the underside of the floor. The most challenging situation arose when working from the upper side, requiring the partial removal of the Venetian flooring to protect the decorated ceilings on the noble floor. Metal supports were then installed, fixed to the masonry to ensure stability.

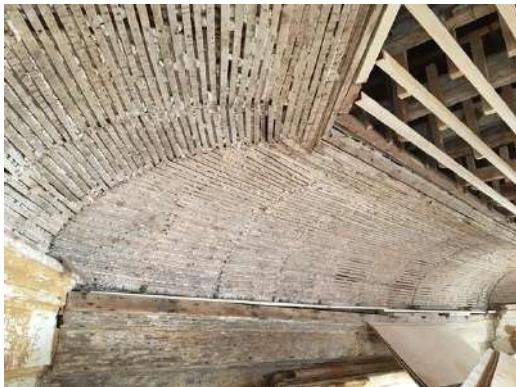
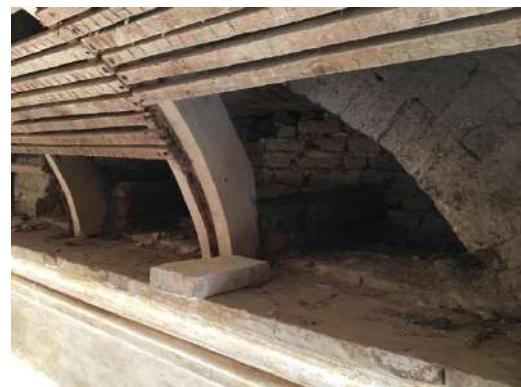
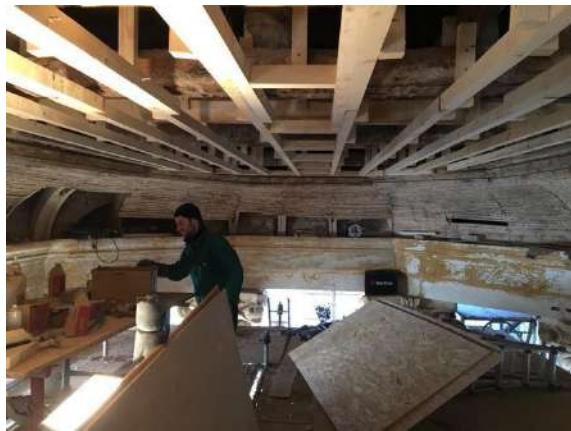
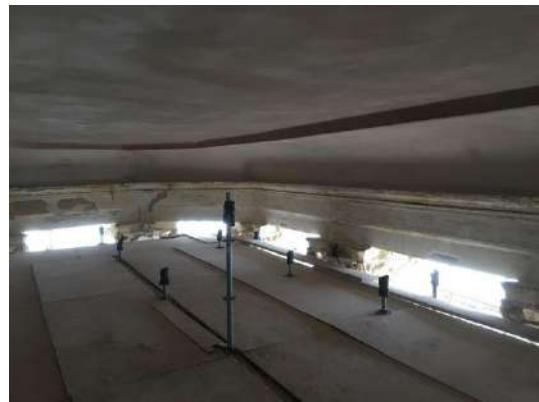
Only by getting closer with the aid of scaffolding were we able to assess the poor condition of the plaster and the supporting wooden structure. It was necessary to carry out the cleaning of all salvageable elements and proceed with the reconstruction of the parts of the structure that were no longer functional.
