RESTAURO MONUMENTALE E ARCHITETTONICO
CONSOLIDAMENTO STRUTTURALE

FOLIGNO (Pg)
ST. FELICIANO
CATHEDRAL

REINFORCEMENT RESTORATION
AND CONSERVATION

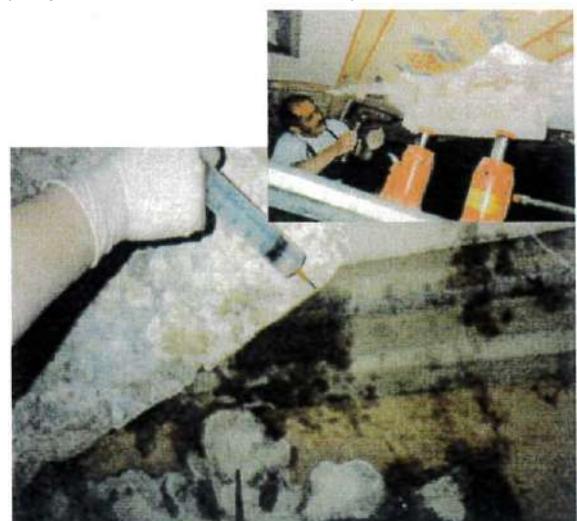
(Steps of the conservation work)

Work started in April 1999 with the initial consolidation of antique plasters by injecting of natural hydraulic lime and acrylic resins and the use of phleboclysis bags predisposed on the surface to allow the slow letting and the complete diffusion of the binding products into the plaster. Cornices and stucco decorations were consolidated using brass bars or wooden poles, integrated with salt free synthetic pastes. Stone elements were consolidated through micro-gluing and the application of steel bars.

The painted areas in the vestry were restored with micro-injection of an emulsion of acrylic resin added with suitable inert charges, into cracks or small existing holes at different depth and with different concentration. The restoration of the mosaic on the facade was fulfilled sealing the damages on the surface with natural, hydraulic lime mortar previously injected in depth with the addition of acrylic resin, and the final integration of missing mosaic tile.
