# L'AQUILA

## DRAGONETTI-CAPPELLI PALACE

SIESMIC IMPROVEMENT OF THE PALACE  
DAMAGED BY THE SEISMIC EVENT OF APRIL 6th, 2009

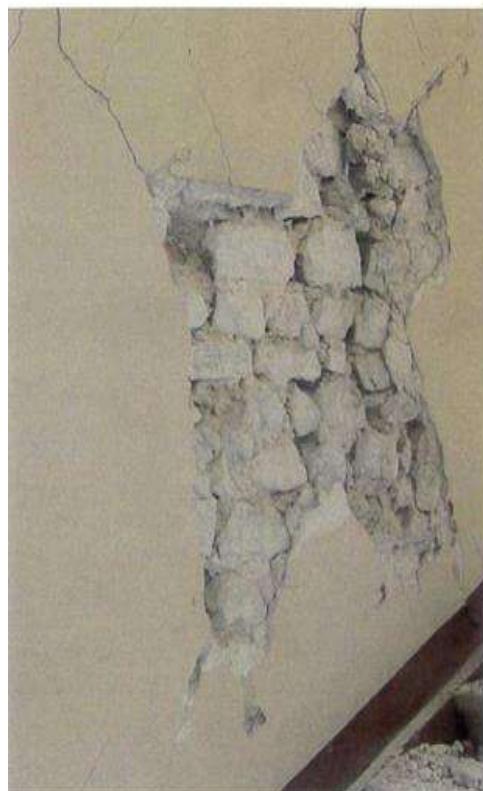
- **reinforcement of the walls against forces in and out the plan (floor)** by means of low-thickness natural hydraulic transpiring lime plaster, reinforced with carbon fiber sheet;
- **reinforcement of the vaults** by restitching of cracks, insertion of wedges to restore the state of loads transmission thanks to the shape restoration, application of carbon fiber sheet tapes to prevent the opening of hinges, cause of collapse;
- **hooping of the building** on various levels by application of high elastic modulus carbon fiber sheet tapes (CarbonIAR system);
- **consolidation of the floors** by means of reinforced hoods connected to the walls to allow the transmission of seismic loads;
- **metal hoops** on openings and for replacing fractured architraves;
- **formation of flat steel tie** rod at the top of the walls;
- **insertion of metal tie rods.**

With these interventions, the building's ability to respond to seismic actions with box-like behaviour is ensured, avoiding the formation of local and global kinematic mechanisms, within the limits of the design approach of **seismic improvement**.

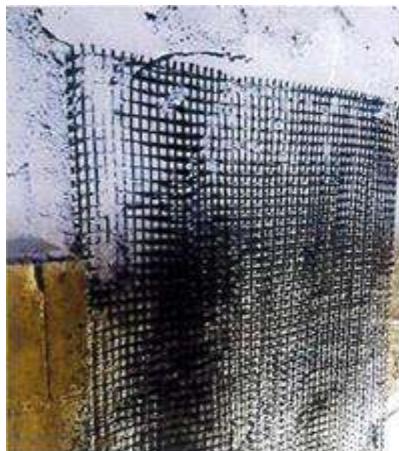
NATURAL HIDRAULIC LIME PLASTER  
REINFORCED WITH CARBON FIBER NET
