RESTAURO MONUMENTALE E ARCHITETTONICO
CONSOLIDAMENTO STRUTTURALE

SANTA MARIA

FORIS PORTAS

THE RESTORATION OF THE CHURCH OF SANTA MARIA FORIS PORTAS

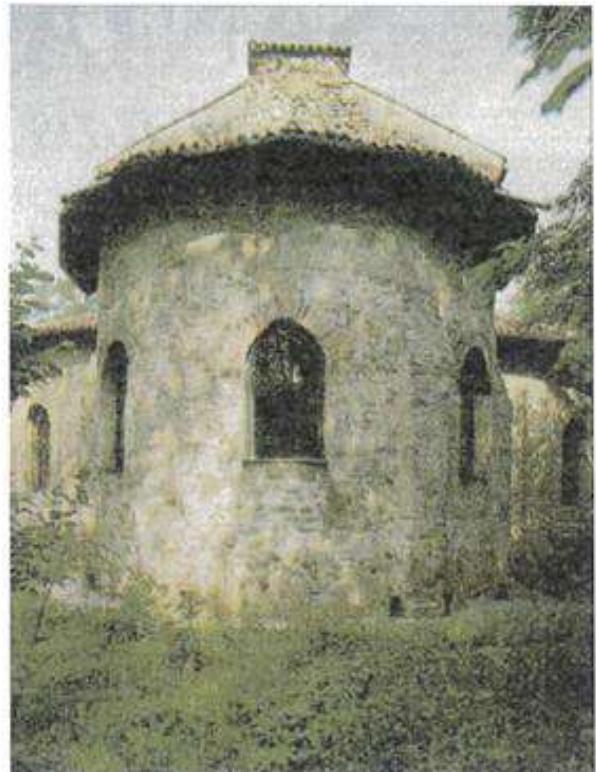
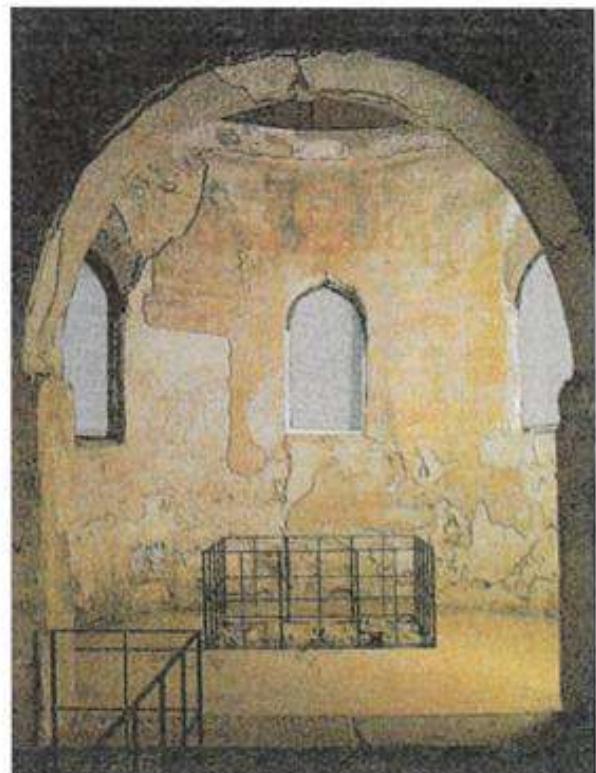
The uncontrolled way in which the vegetation grew, the notably humid climate and the presence of a nearby pool of spring water, have originated the conditions under which the disruptive action of humidity, very active throughout the year, has affected all the structures in the form of mold, lichen and condensation.

The problems recorded both inside and outside the church, were the cause of worrying degradation phenomena, especially for the precious pictorial cycle.

(External and internal view of the Apse)

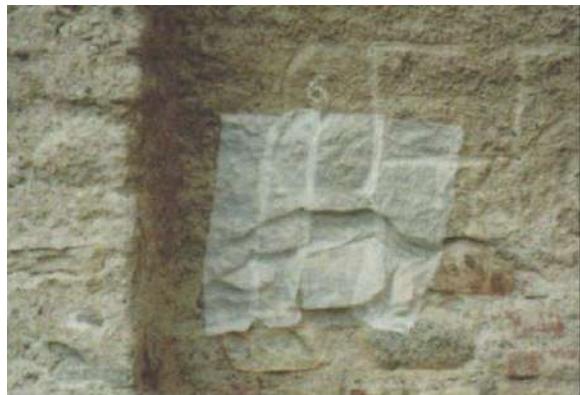
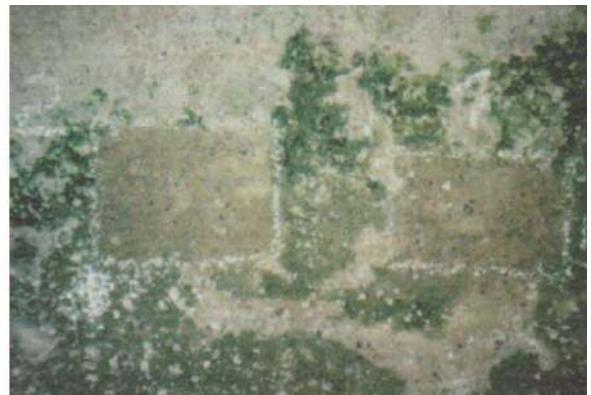
(Photo of restoration from the biological attack of the plaster with "Japanese paper")

The excessive humidity of the internal microclimate of the church, with the consequent insalubrity of the air, caused the deterioration of the paintings depicting the childhood stories of Christ.

The deterioration of the plasters, their progressive detachment caused by the drenching and the continuous washing away from rainwater led to the disintegration of

the bedding mortars with the consequent formation of cavities and detachments of material, both localized and extended.

- Realisation of a chemical barrier at the base of the walls for reducing the capillary rise of soil moisture, injecting siloxane-based resins into the bedding mortar courses;
- Recomposition of walls and plaster, where these were disaggregated or insufficient, with mortars formulated according to the indications provided by Laboratory Tests;
- Consolidation of the not cohesive plasters of the most damaged and susceptible to fall area, by glazing with Japanese paper attached to the surfaces with acrylic resin.

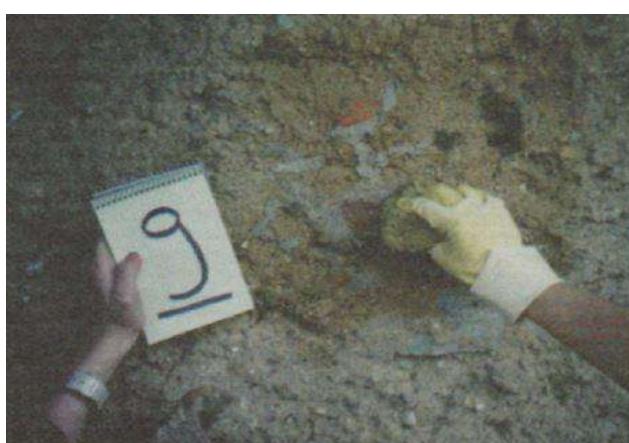
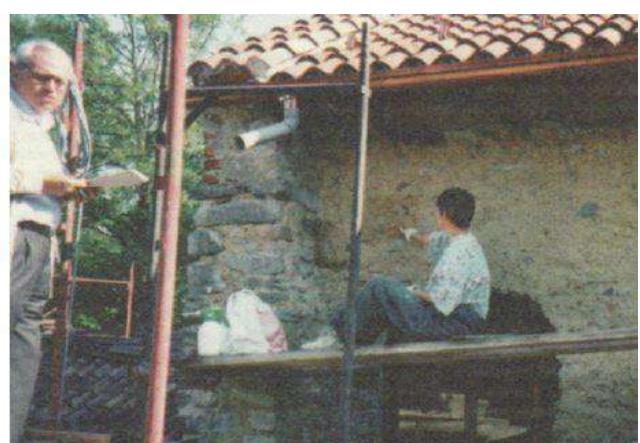
(Detail of the cleaning and consolidation phases of the plaster)

Prior to all this, a general cleaning of the surfaces have been carried out with detergent and emollient wash using deionized water, intervening where necessary with soft silky brushes.

All the wall surfaces were then treated with a water repellent based on oligomer siloxanes, applied by spray.

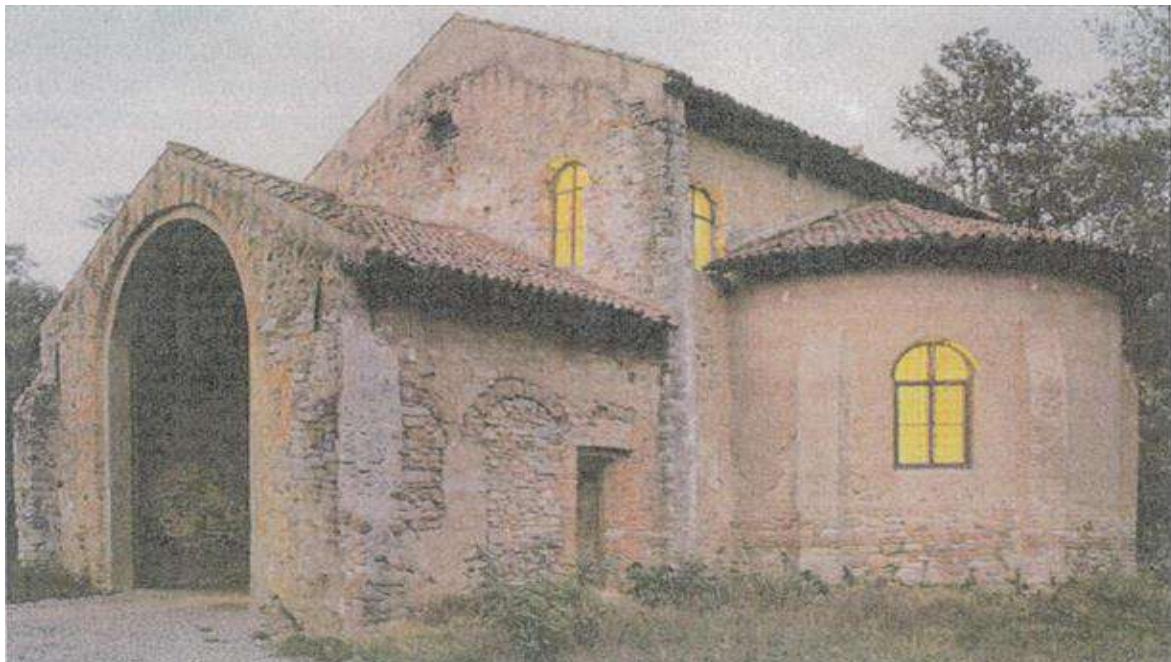
Furthermore, it should be remembered that, at the same time as the restoration of the Church, in the nearby areas, traces of possible archaeological pre-existences were sought. To this end, geophysical investigations were carried out using the georadar for the identification of buried structures and the preparation of explanatory maps.
