# **AERONAUTICAL SECTOR**

**APPLICATION :****HYPERCOAT® 90103**

## **TESTS CARRIED OUT**

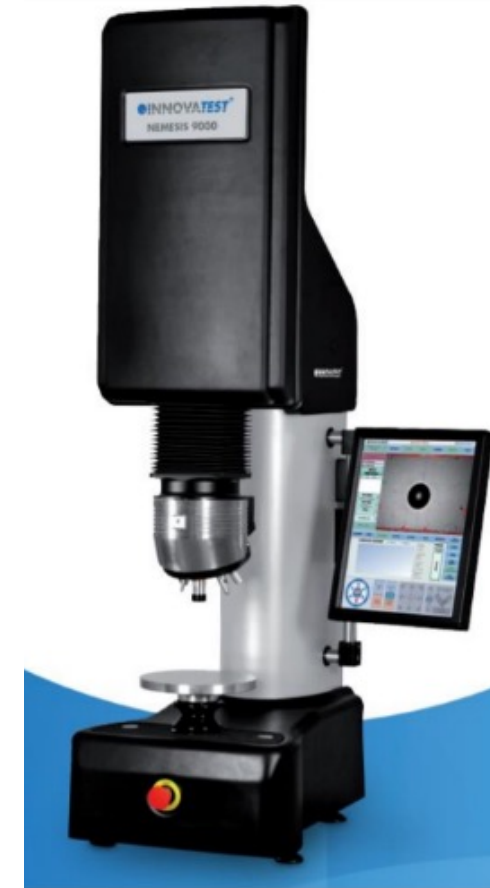
# SUPERFICIAL HARDNESS

The experimental hardness tests were carried out on carbon fiber panels with the following features:

The testing machine is equipped with an optical microscope with magnification up to 10x and an indenter positioning sensor. For each slab, two rectangular-shaped specimens measuring 50x25 mm were cut, and 3 acquisitions were performed on each of them at different points, for a total of 6 hardness acquisitions for each slab

| MATERIAL | BRINELL HARDNESS | | |
|---|---|---|---|
| Plate 1 – HYPERCOAT 90103 | 67,12 | 0,66 | + 14% RESPECT UNTREATED |
| Plate 2 – Untreated | 57,99 | 1,34 | - |

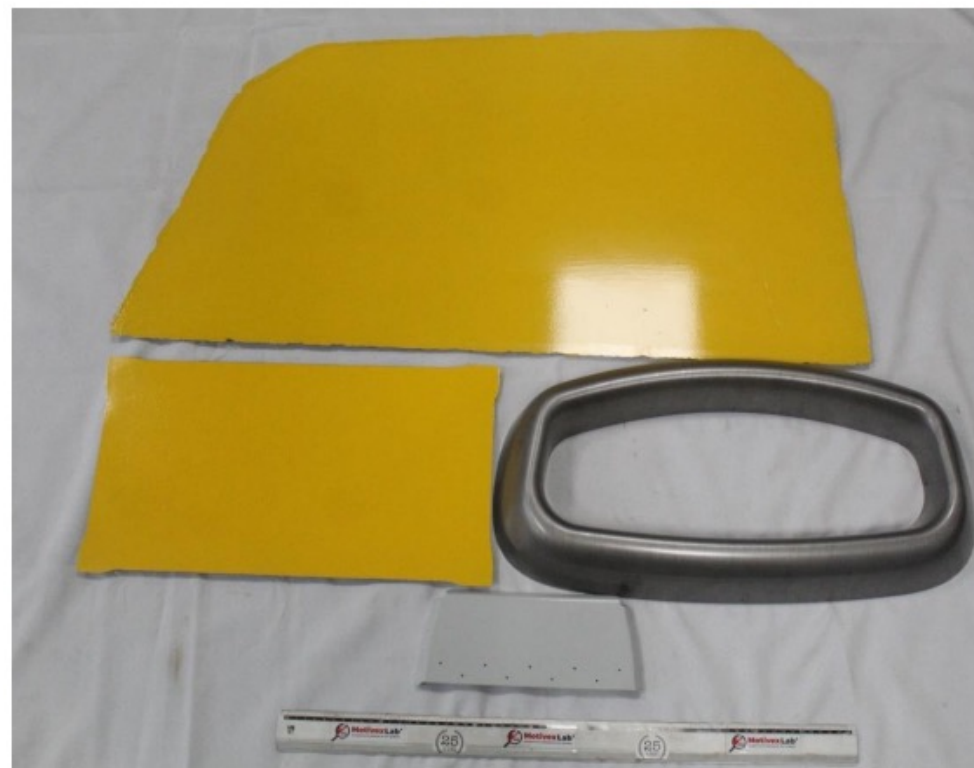
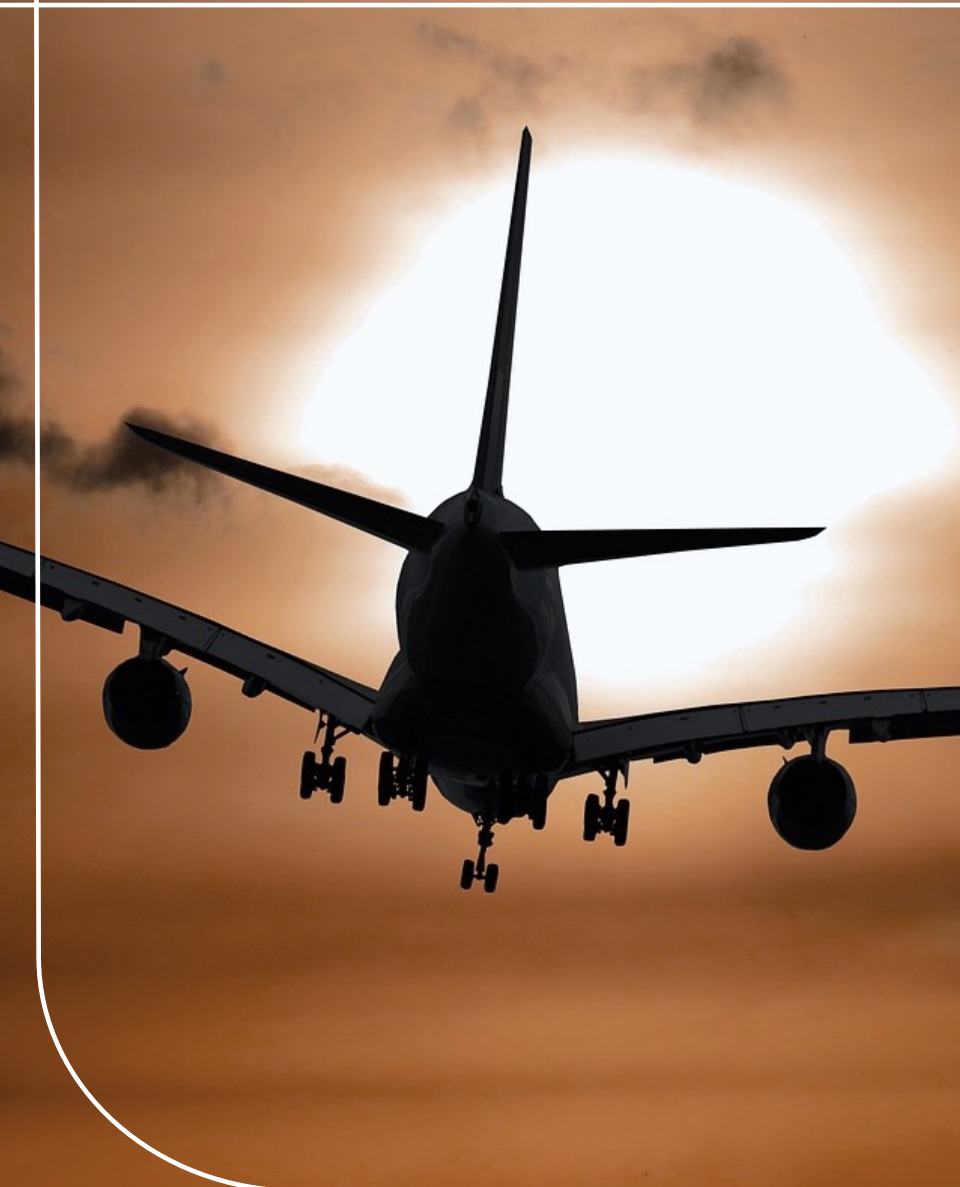
Evaluation after 800 hours QSUN TEST of the resistance of surface coating on paint obtained with HYPERCOAT 90103, alternating UV rays, heat, water and rest period.

The protection after 800 hours has maintained the initial gloss level, has remained intact and has not lost its mechanical characteristics.

The protection has passed the QSUN test, lasting 800 hours in total in outdoor conditions. The material has been protected from UV rays, hot-cold cycles and the humidity expected in Qsun outdoor cycles.

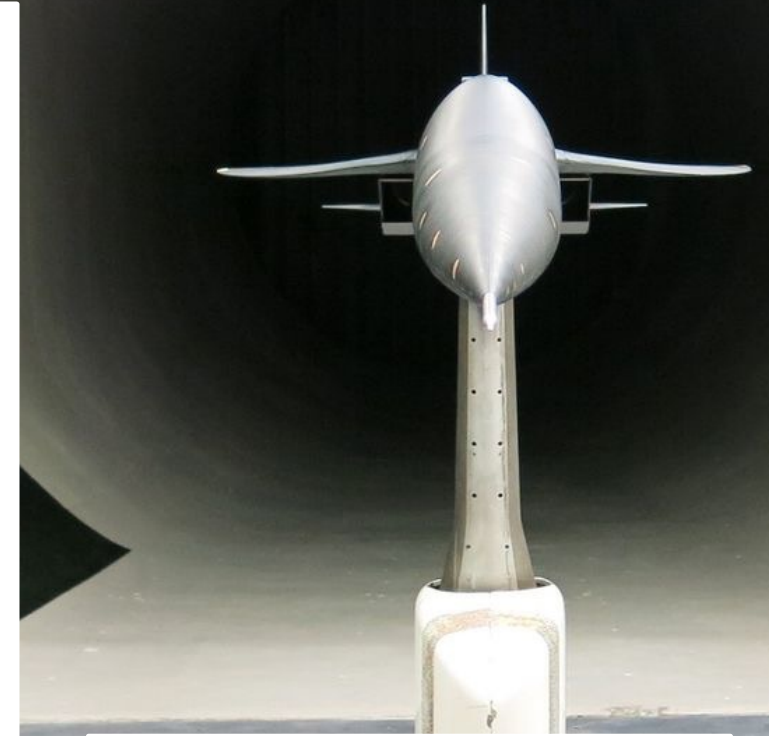
The model is NACA 0021 composed of two parts in aluminum alloy:

- a front body with a 3:1 elliptical profile and
- a cylindrical main body with a sharp-edged base perpendicular to the axis.

The characteristic dimensions are:

- Diameter  $d=70$ ;
- Length  $l=400$  mm.

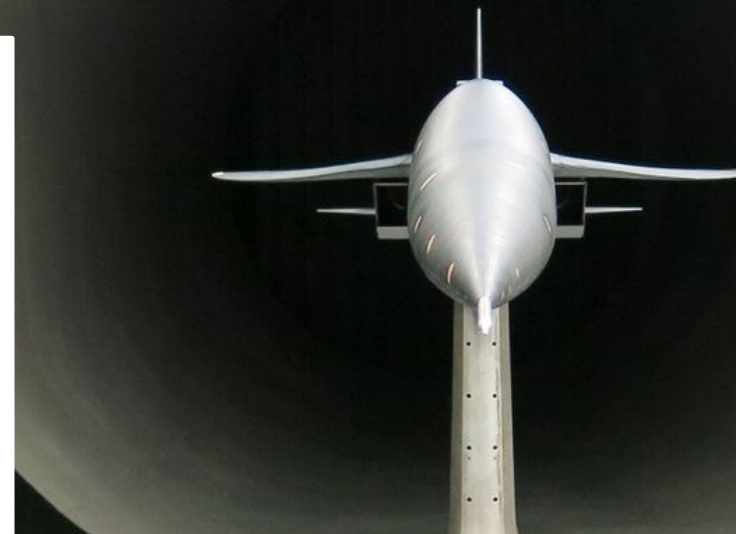
Velocity and pressure measurements were conducted in order to characterize the flow around an axisymmetric body, in order to evaluate the effects of a surface treatment. The thickness of the boundary layer increases with surface treatment.

The model treated with HYPERCOAT 90103 has a reduction of approximately 7.0% in surface friction and a decrease in turbulence of around 4%.

The pressure maps attest to less suction on the base, and therefore less pressure resistance.

The table shows the slopes of the wall velocity profile, from which yes obtain the value of the friction action:

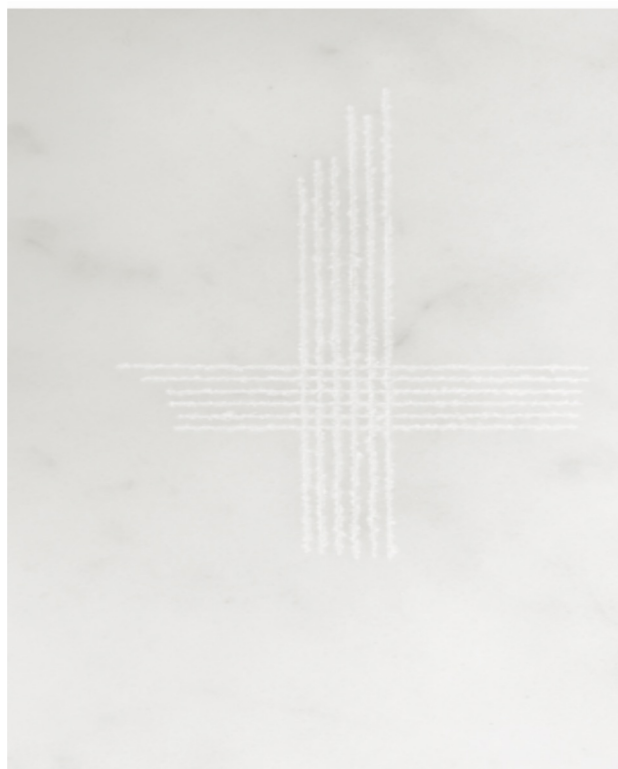
**SAMPLE TYPE: EPOXY PAINT COATED WITH HYPERCOAT 90103**

**Squareness test (UNI EN ISO 2409:2020).**

**Level rating: 2**

**No detachment of the surface treatment**

**Tape Test (ASTM 3359 Method)**

**Level rating: 4A**
